# The effects of changing plant operational modes on Boiler Water Circulation Pumps

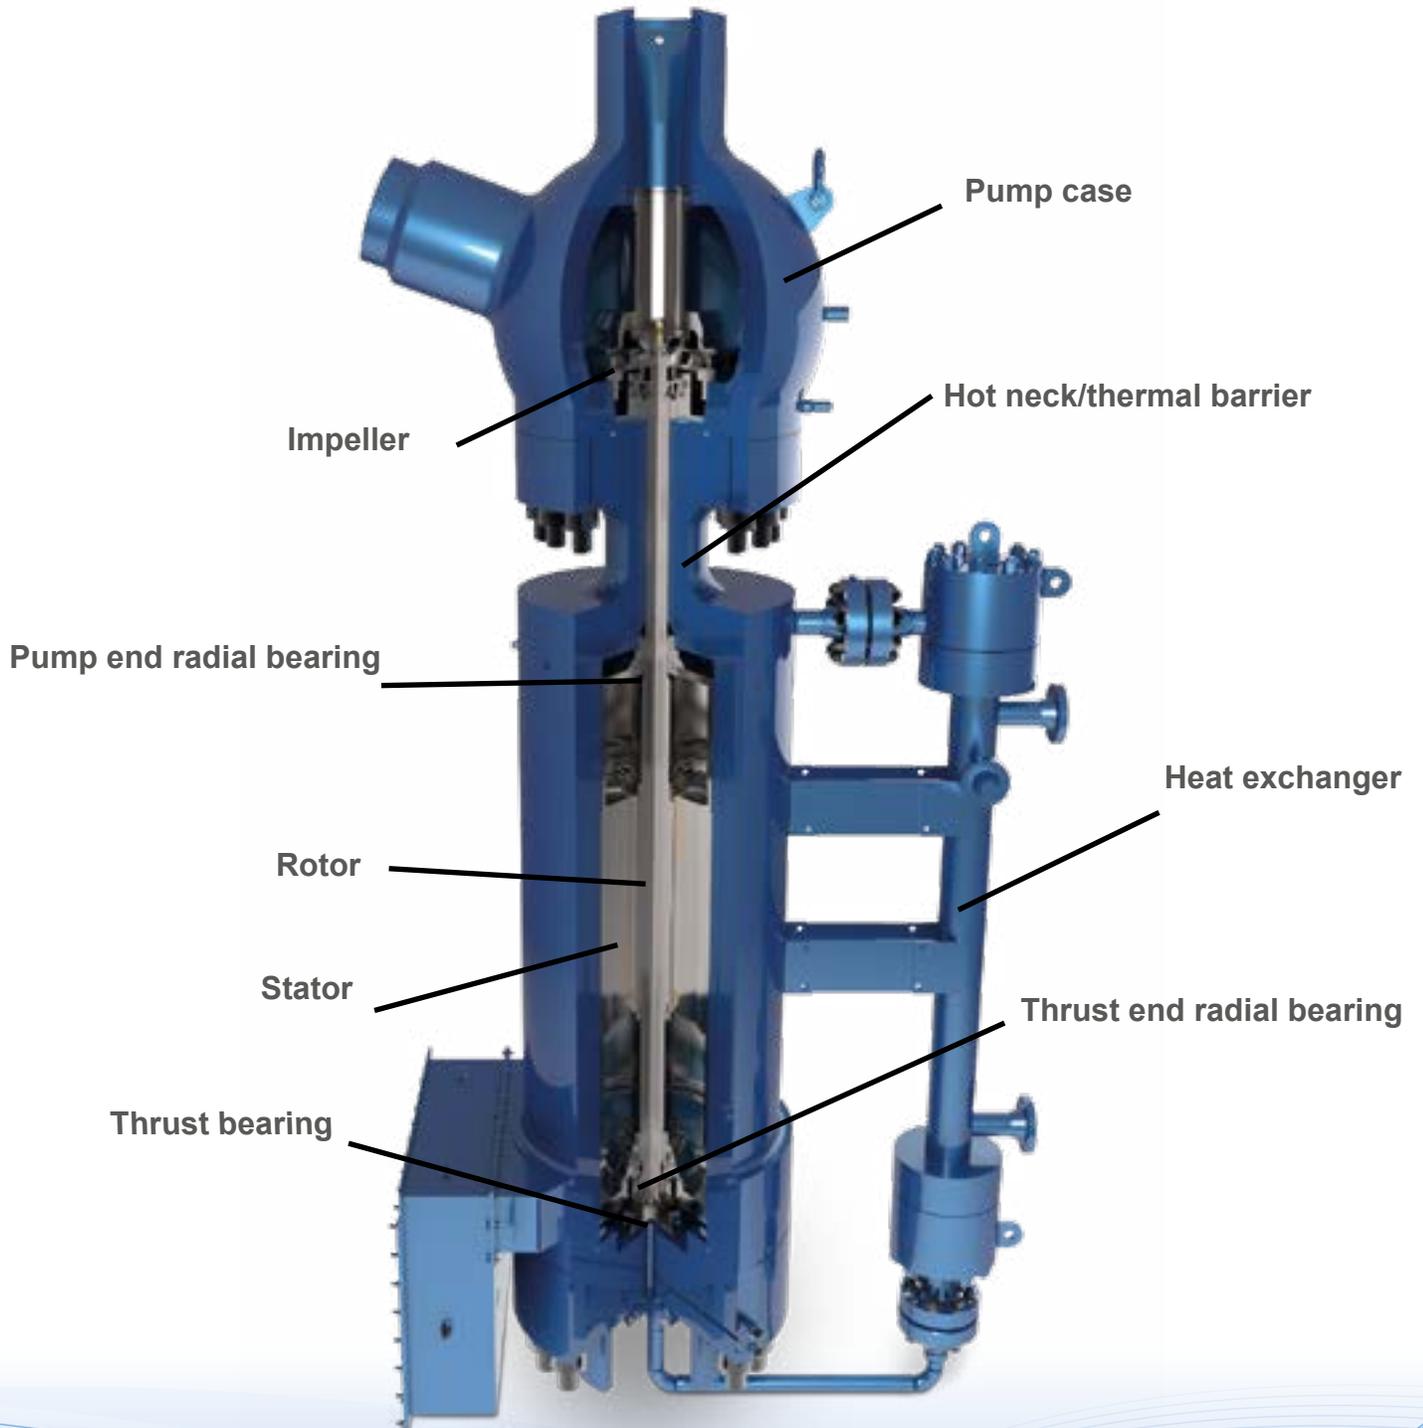
Figure 1- Typical BWCP

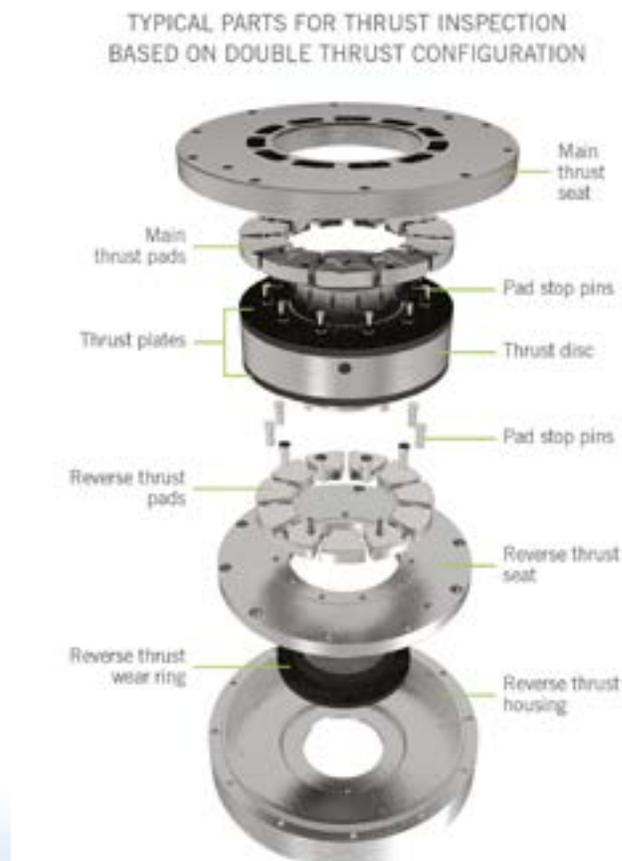
Figure 2- Typical double thrust bearing configuration

A typical BWCP is supported axially using a hydro-dynamic thrust bearing. The bearing works by using a water wedge that is formed between the thrust disc (which is keyed to the shaft) and tilting thrust pads. The thrust bearing is designed to accommodate the weight of the rotor and additional thrust loads from the pump including a suitable design safety factor. When the motor starts up the hydraulic lift from the impeller lifts the rotating assembly upwards to establish a film of water between the thrust bearing surfaces during stable operation. When the BWCP is shut off the rotor loses the hydraulic lift and returns down to the reverse thrust bearing. Initially during start-up there is insufficient fluid film between the non-metallic bearing and the thrust pads therefore the friction between the pads can cause a small amount of material wear. This reduces the thickness of the bearing material and begins to open up the distance the rotor can travel (“rotor end float”). This means that the rotor is travelling further every time the motor is de-energized resulting in a larger thrust being absorbed by the bearing.

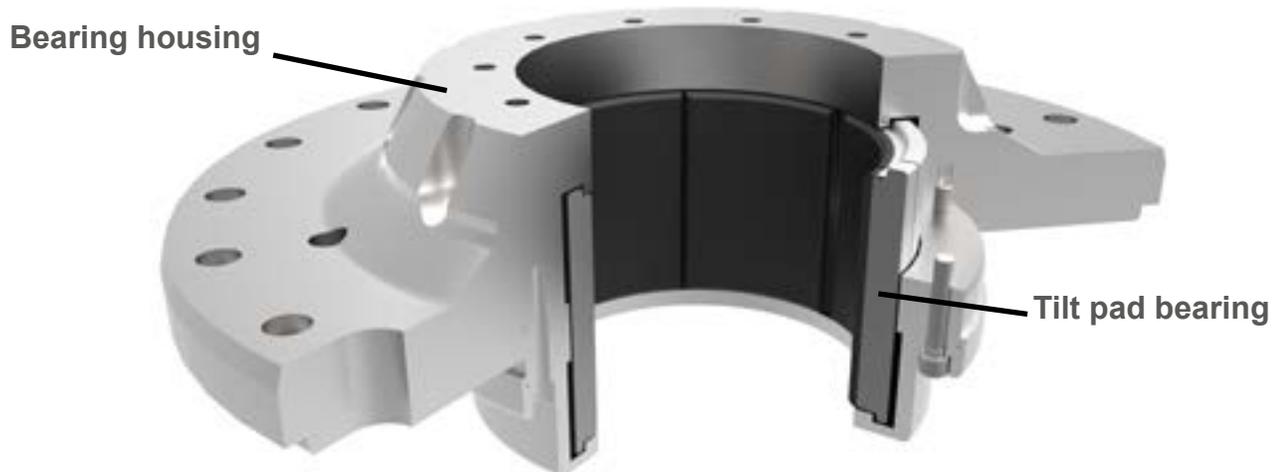
Figure 3- Sectioned bearing housing showing radial tilt pads in-situ

Similar to the thrust bearings, the radial bearings in the BWCP use hydrodynamic bearings. The radial bearings are located at the thrust end and pump end. Accurate alignment of the radial bearing is controlled by manufacturing tolerances of the stator housing and motor case. The radial bearings are sized to absorb loads from unbalanced magnetic pull (UMP) on the rotor, hydraulic fluctuations in the pump creating unbalanced loads and ensure safe rotor dynamic characteristics. When the BWCP starts there is insufficient fluid film between the journal sleeve and the bearing surface. Like the thrust bearing this creates wear on the pads resulting in lost material and larger clearances. This is a propagating effect as the bearing wear allows the rotor to deviate from the center axis of the stator which increases the UMP and hence increases bearing wear. Increased bearing wear allows the rotor to deviate away from alignment with the stator and hence the damage propagates due to worn radial bearings. If the bearing clearances become excessively large under extreme conditions the UMP during start-up could cause rotor to stator contact due to bending in the rotor. This could cause damage to the stator and rotor lamination packs resulting in the need for restacking.

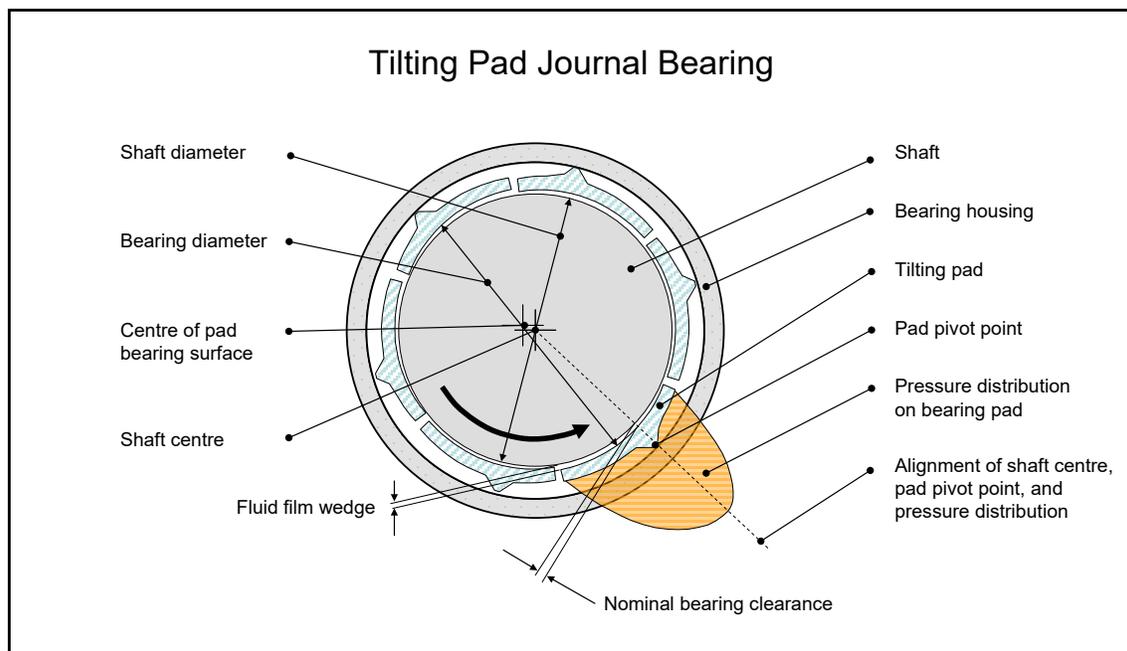
Figure 4- Typical configuration of tilting pad journal bearing (shaft sleeve not shown)

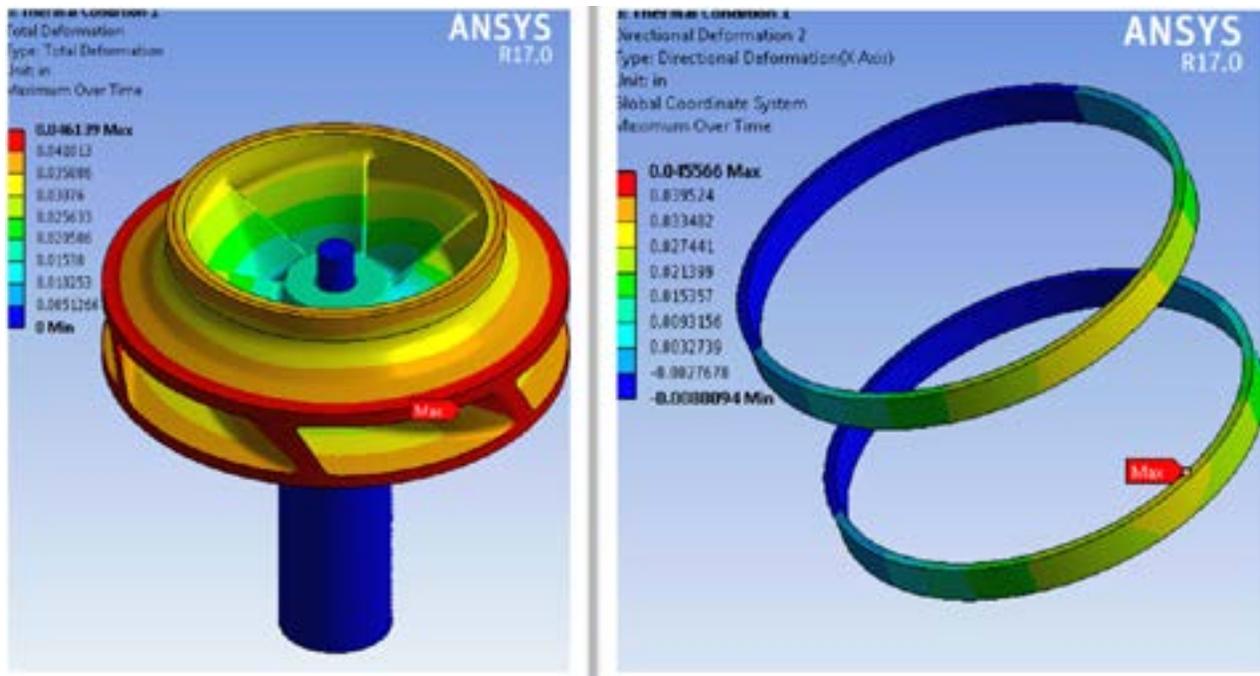
Figure 5- Thermal expansion of impeller (left) and wear rings (right)

The impeller wear ring is set with a pre-determined diametrical clearance to the pump case/diffuser wear ring in order to control the pressure drop across the surface and the amount of fluid recirculated. In addition, the distance from the pump case to motor case mating face and end of the impeller (known as the “A” dimension) is controlled to ensure no axial contact. Under scenarios where the plant is quickly changing load or fully starting and stopping the motor there is typically a temperature difference between the pump case and rotating assembly. Depending on that temperature differential the impeller and pump case will grow or shrink at different rates from each other. This reduces the wear ring clearance and can cause contact. In severe situations binding of the rotating assembly to the static wear ring can occur. Frequent load changes will cause accelerated degradation to the wear rings. This increases the clearance and reduces efficiency (due to increased recirculation) but, more severely, shortens the life of the wear rings and can cause major damage to the impeller and rotating assembly. Excessive contact of the impeller to pump case can bend the rotor, damage the radial bearings and have consequential effects of damaging the stator windings due to debris being circulated through the motor.

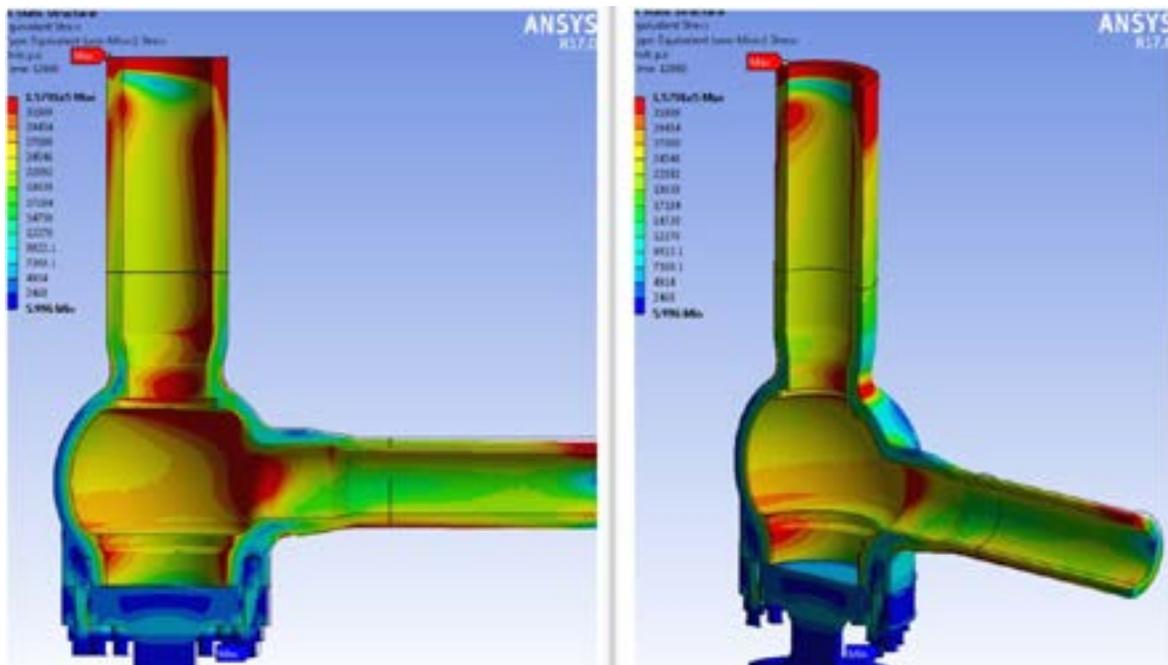
*Figure 6- Thermal stresses on pump case due to fluid/metal differential temperatures*

The above two images show the highest stressed areas of a representative pump case and are the areas that should be inspected first for fatigue cracking.

The pump case on a BWCP is welded into the pipework and typically made from a thick walled carbon steel casting. Frequent thermal cycling on the pump case due to changing operating loads subjects the pump case to thermal stresses as the pump case tries to expand freely however is constrained by the pipework and connection to the motor. Frequent thermal stress cycling can present problems with fatigue crack development at critical regions such as changes in thicknesses, nozzle regions and welds. Operators undertaking frequent load changes and thermal cycling should ensure to inspect pump cases for the development and propagation of cracking. If the pump case welds are not part of a maintenance program associated with “high energy pipework” they should be included in the periodic inspection of the pump case.

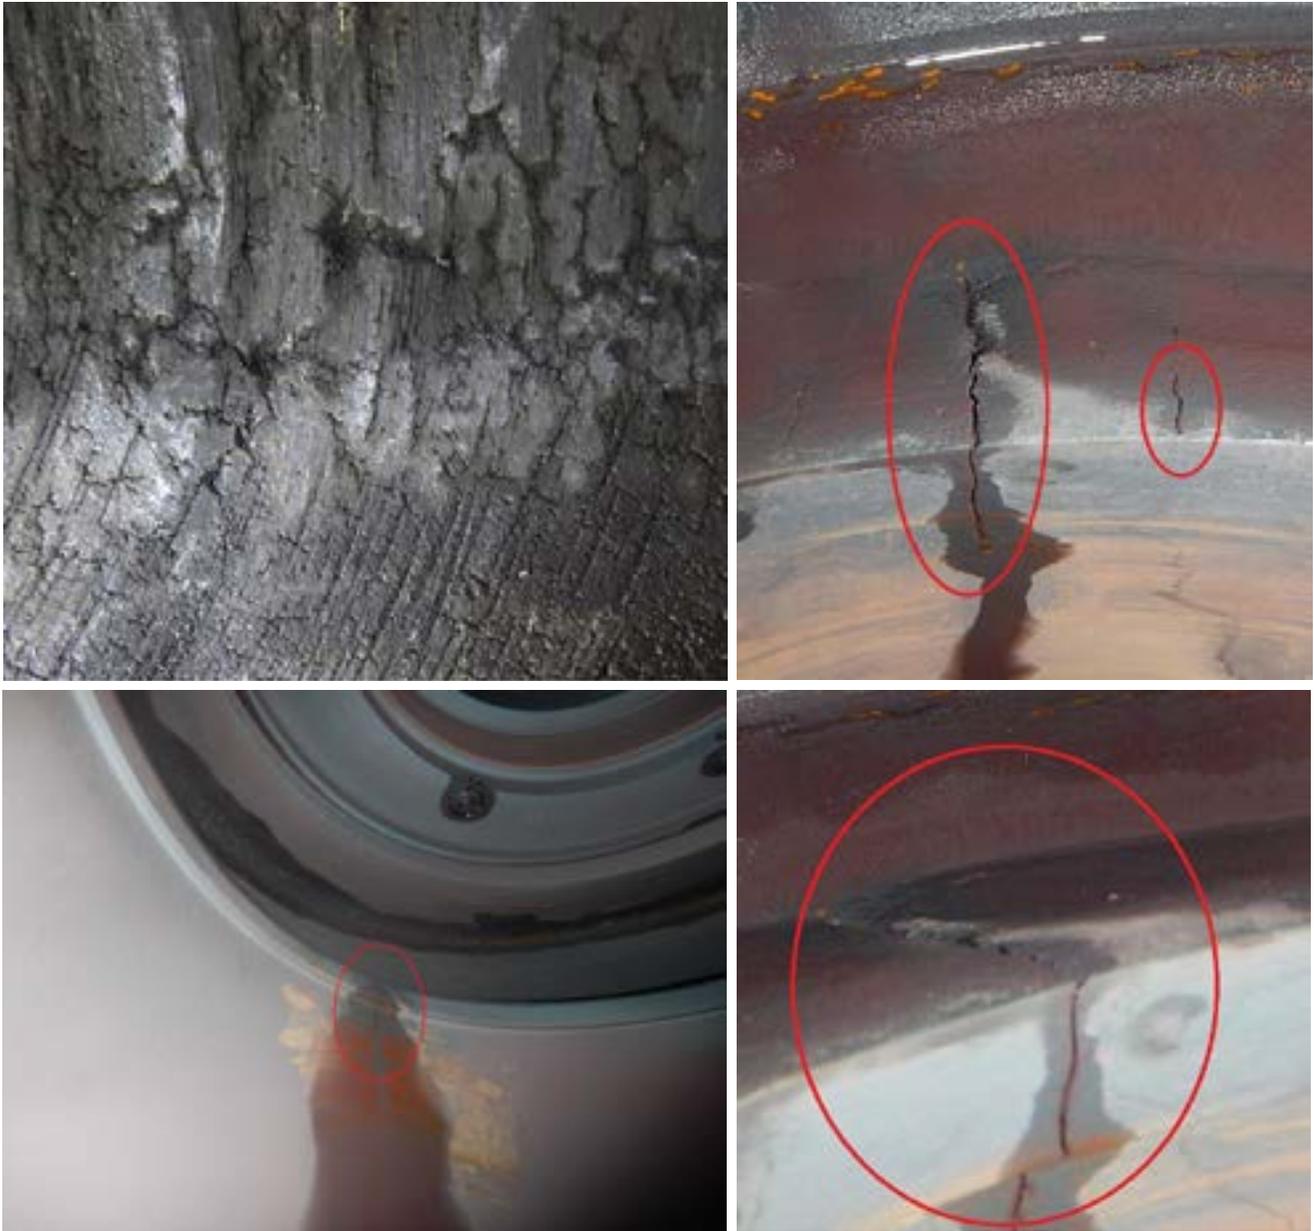
*Figure 7-Cracks in BWCP pump cases*

The above images show cracking that was discovered in BWCP pump cases. The cracking caused extended downtime for the plants involved.

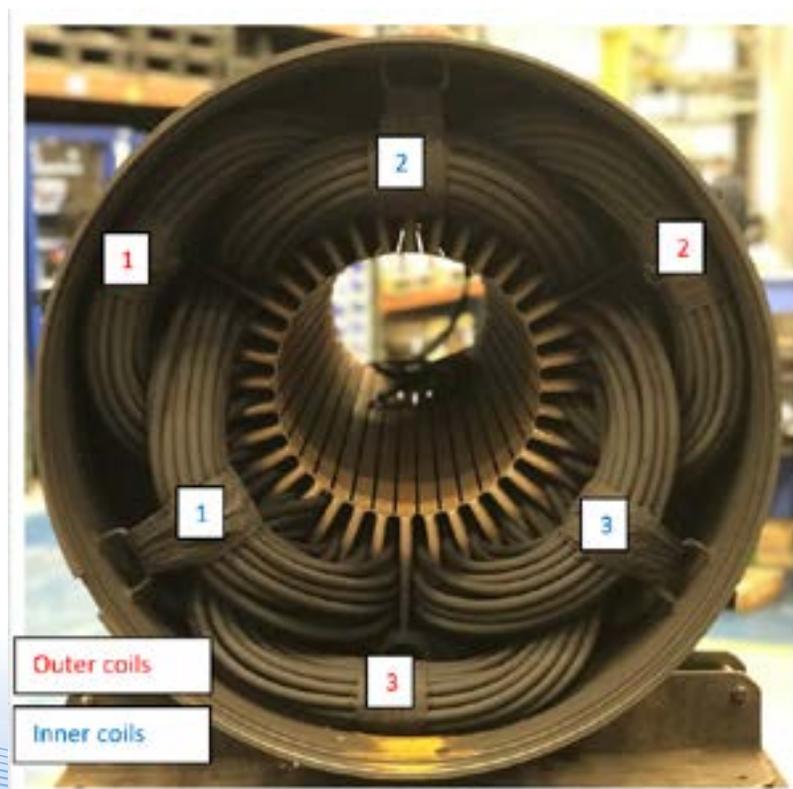
Figure 8- Stator end turns showing coils

When the stator is initially wound the cable in the slots are wedged together to keep them packed tightly together. With normal operation of the electrical motor, the cable in the slots bunch together and pull to the outside of the stator due to the magnetic forces in the motor. This can have the effect of the cable becoming looser in the stator slots allowing additional cable movement. A typical 4 pole wind is shown below in figure 8.

During the start-up of the electrical motor the cable in the end turn phases exert magnetic forces on cables in adjacent end turn phases causing the end turns to move and vibrate. The outer coils are pushed towards the outside of the stator shell and the inner coils are pulled towards the rotor. The end turns flex with the changing magnetic fields induced by the incoming current.

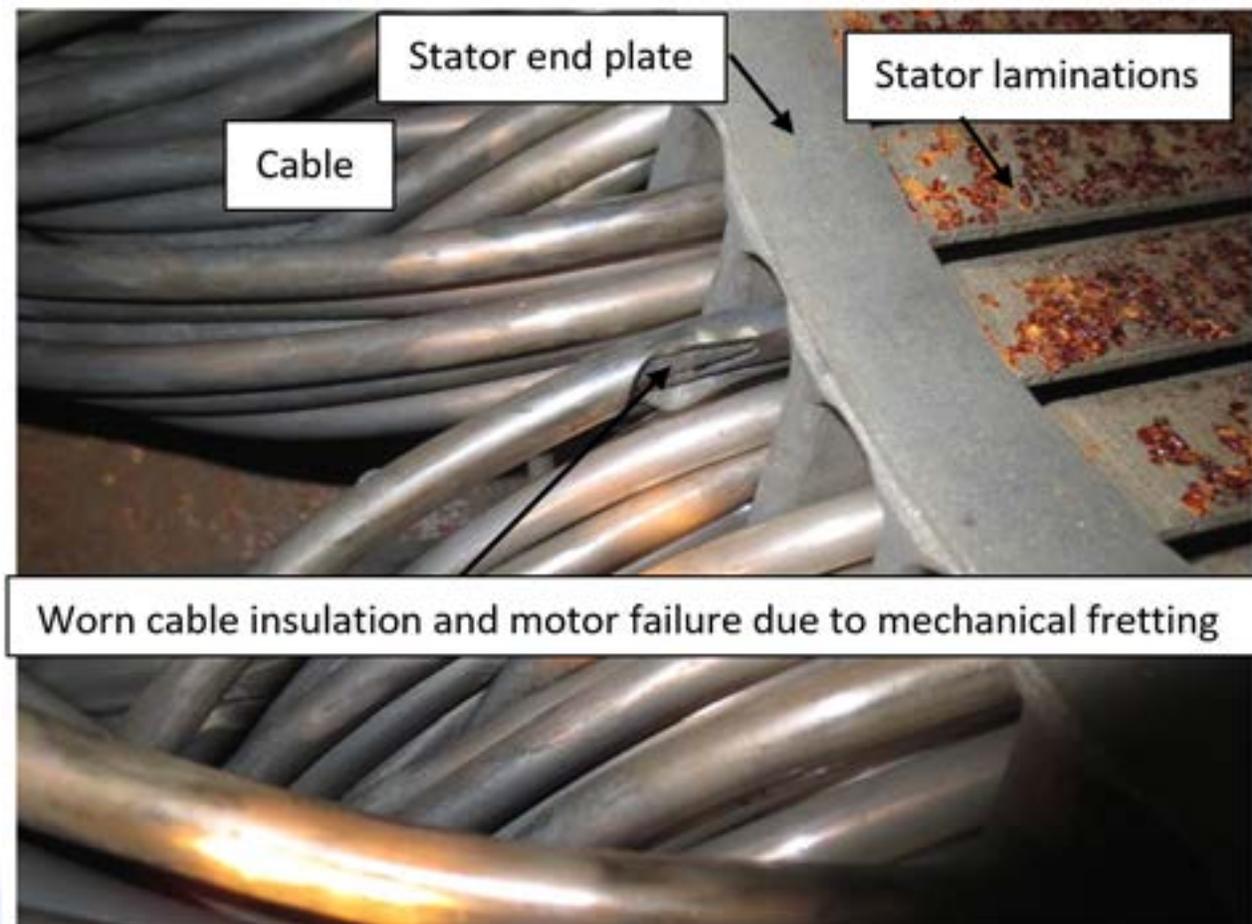
Figure 9- Failure to ground due to mechanical fretting and insulation wear

Over time with high numbers of starts to the motor (more than originally designed), this end turn cable movement, combined with the increased movement in the slot can result in the cable rubbing on the stator end plate. If this behavior continues the cable insulation wears down until an insulation failure occurs (as shown in Figure 9). In some occasions the insulation failure causes an electrical arc which damages the stator end plate and stator laminations. This can mean a full or partial restack is necessary along with a stator rewind resulting in extended motor down time and significant repair costs.

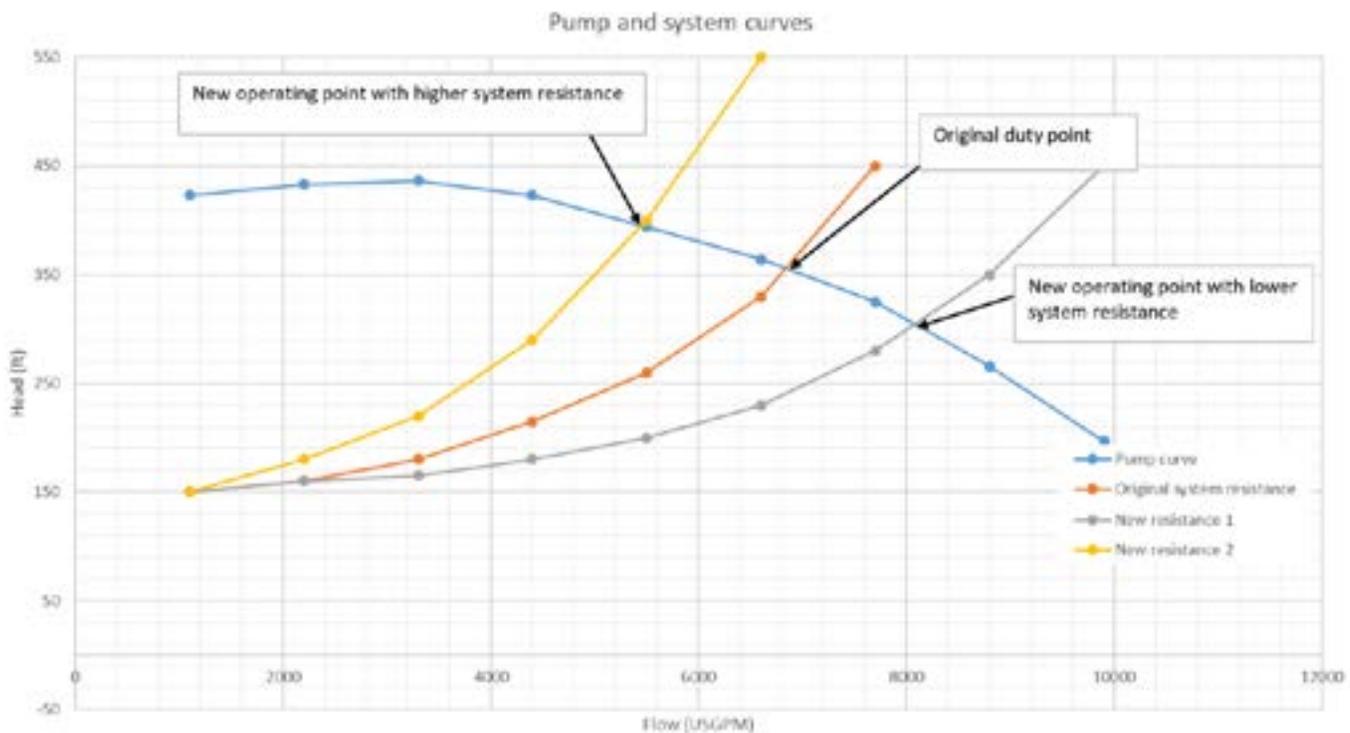
Figure 10- Pump curve and various system resistance curves

Originally when the power plant was designed a system resistance applicable to the BWCP was calculated based on the designed static head plus the frictional losses due to pipework, valves, orifices etc. in the system. The frictional losses aspect of the calculation varies with the square of the flow. The pump will operate at the point where the pump curve and system curve intersect. The pump curve only changes if the speed of the motor is changed or the impeller diameter is changed, both of which are very uncommon on BWCP's. Changes to the system such as modified valve arrangements, changes to pipework configuration or diameter, degradation of drum baffles etc. all have an effect on the system resistance which in turn dictate where the pump operates along its pump curve. This can result in the pump being operated away from its originally designed duty point which can cause increased vibration in the BWCP. Increased vibration will result in accelerated damage to the radial bearings and thrust bearing. If the system resistance has increased the pump will run back on the pump curve i.e. lower flow, higher head. The increased differential pressure across the impeller can cause increased thrust on the rotating assembly accelerating bearing wear.

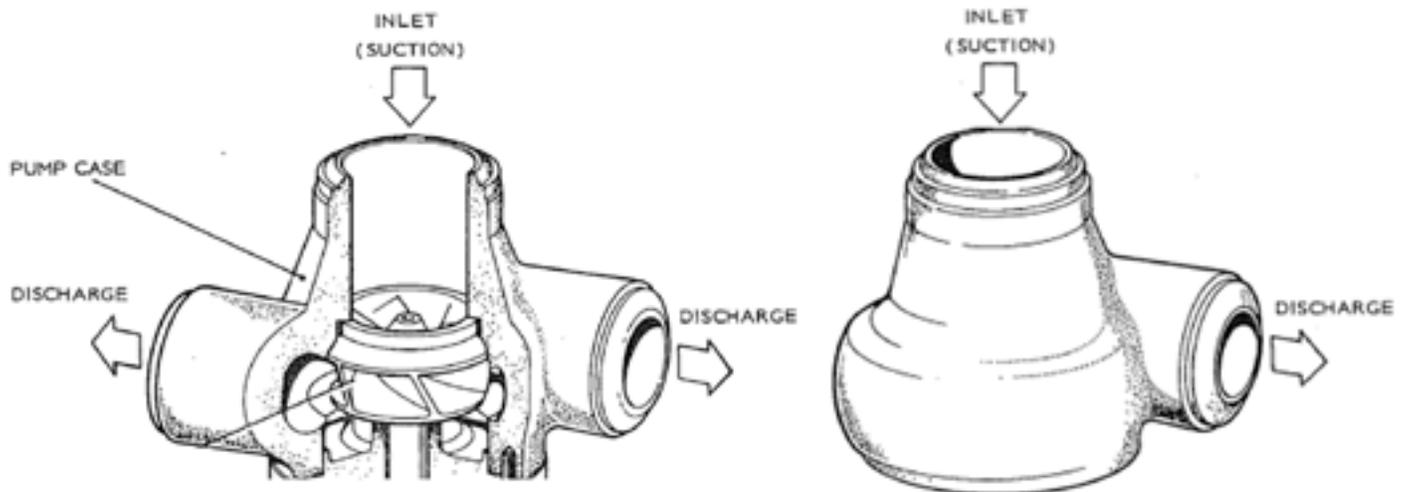
Figure 11-Double discharge configuration (left) and single discharge (right)

The BWCP either has a single discharge or a double discharge from the pump case as shown below.

In both cases the discharge pipework has an isolation valve to isolate the BWCP from the boiler. If the discharge valves are not well maintained they can partially close when un-intended and this has a negative effect on the BWCP. If the discharge valve is partially closed with the pump in operation it will force the pump to operate back on the pump curve with a large differential pressure across the pump. The increased differential pressure across the impeller can cause increased thrust on the rotating assembly accelerating bearing wear.

In the case of double discharge pump cases, if one of the discharge valves has not been maintained and floats to a partially closed position this effects the alignment of the impeller within the pump case. The impeller and rotating assembly will tend to locate away from the discharge with the partially closed valve. The off center alignment will cause un-even wear on the radial bearing which, as discussed previously, will increase the UMP on the rotor.

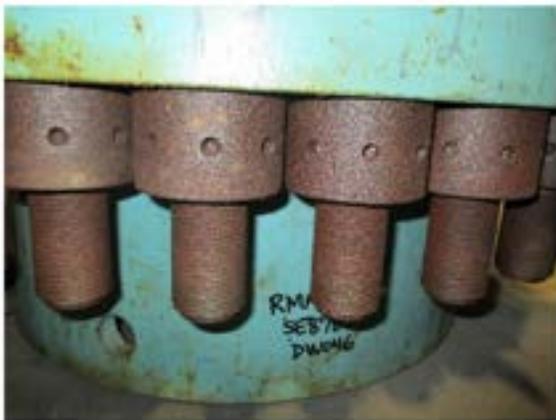
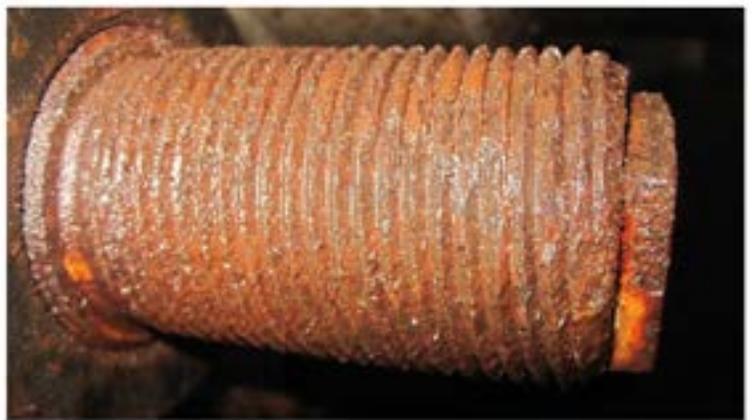
Figure 12- Corroded motor cover studs (left) and close up of stud (right)

Long term neglect of the pump case and/or motor cover studs of a BWCP can cause them to corrode and seize in place. New pump case studs have a zinc phosphate coating to improve corrosion resistance and paint adhesion followed with a high temperature anti-friction coating. If the pump case/motor case gasket has leaked or the plant environment is frequently subject to water the studs can corrode and bind in place. Often the only way to remove the studs to allow servicing of the BWCP is to cut them out. This causes an unnecessary expense for the plant requiring them to purchase new studs, often on an expedited basis.
