# Dealloying Issues in Aging Service Water & Circulating Water Pumps

## *Is material quietly disappearing from your pump?*

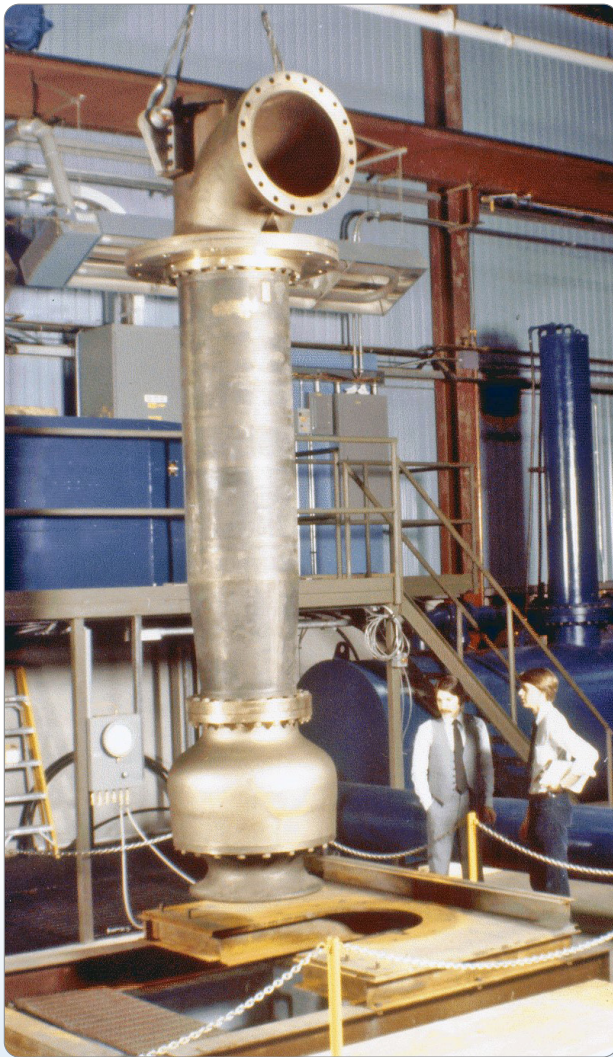
Image 1: Original Service Water Pump (circa 1970)

Many pumps in service water and related applications were originally constructed using aluminum bronze to withstand the demanding service conditions. Aluminum bronze alloys have excellent wear, galling, and corrosion resistant characteristics while providing high strength. When compared with other readily available corrosion resistant alloys such as austenitic stainless steels, selection of higher strength aluminum bronzes often allowed for reduced material thicknesses and lower overall costs for vertical pump applications. These

pumps typically consist of large castings and fabricated components where appreciable savings could be realized. Selection of aluminum bronze also offered enhanced seawater corrosion resistance and resistance to biofouling compared with many similarly priced alloys at the time of original construction.

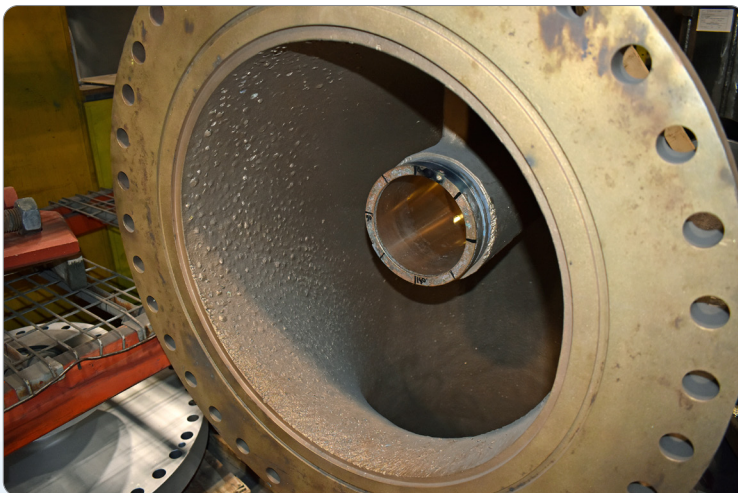
**Image 2: This image shows the as received condition of an Aluminum Bronze Service Water Pump discharge elbow. The other pump components were all in similar condition.**

Selective leaching can be difficult to identify by visual inspection alone as it often does not cause dimensional changes along with the changes in microstructure and reduction in tensile strength. However, more severe dealuminification can manifest macroscopically as dark, copper-colored areas on the metal's surface. The use of acid etching can also aid in identification by visual inspection.

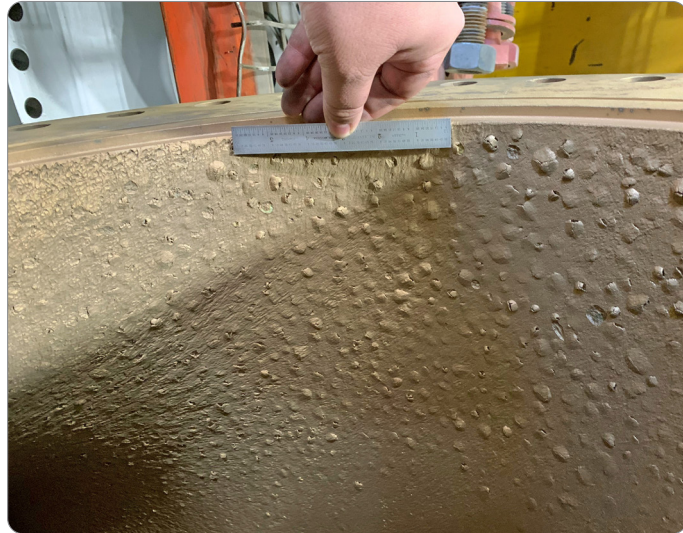
**Image 3: Corrosion on the internal surface of discharge elbow.**
