Damaged Municipal Water Valve Repair Ensures Continued London Water Supply

Field service engineer discovers excessive damage during routine inspection and executes a difficult on-site repair.

London Water Main

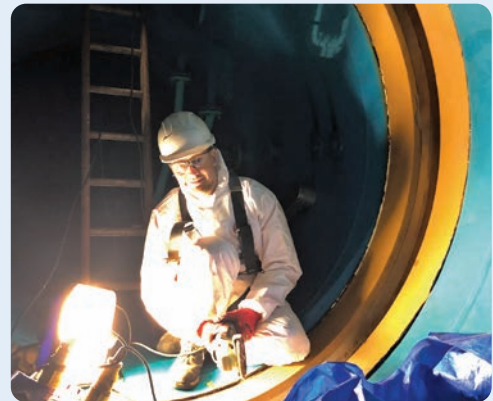
Repair work inside pipework

The HT FSE performed an assessment of the damage to the sealing face and quickly devised a simple yet effective weld repair plan to get the water main back to an ideal condition as quickly as possible. For two full weeks, the FSE manually welded, repaired, and grinded the valve face back to an acceptable condition. They also installed a new gate and shaft assembly and carried out the commissioning of the repaired valve to ensure it performed its critical function. This repair was completed within the main water pipework, in a confined space, with reduced visibility.

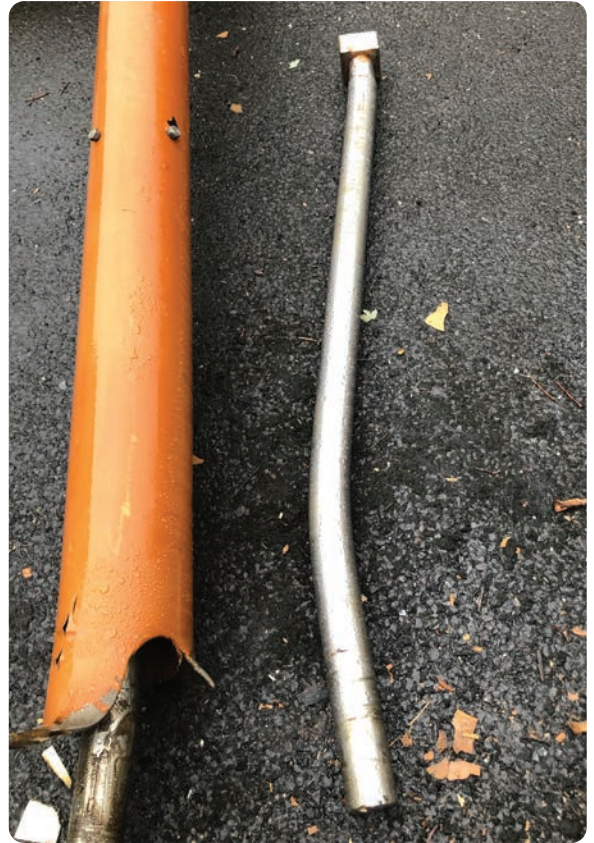
A Hayward Tyler Field Service Engineer (FSE) was on-site investigating a bent drive shaft when they identified more extensive damage to the valve.

Bent drive shaft

- Inspection of High Integrity Gate Valves
- Assessment of damage found
- Creation of repair plan
- Welding and Grinding within a confined space
- Install new gate and shaft assembly
- Commission repaired valve

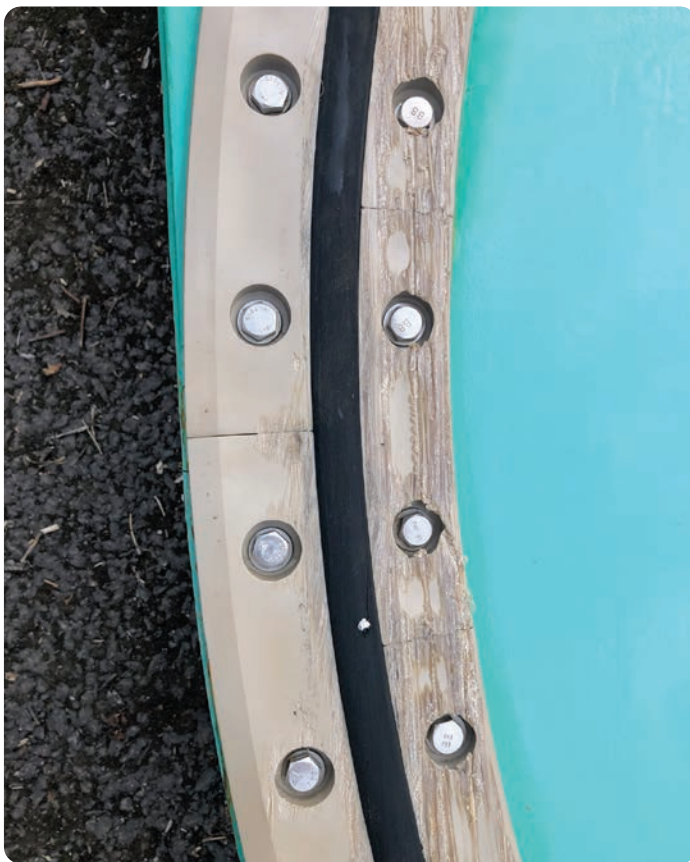
Excessive differential pressure had exposed the fixing bolts, causing them to tear the valve sealing face. Additionally, there was extensive damage to the valve shaft and bolting during the removal of the existing gate.

Damaged valve face

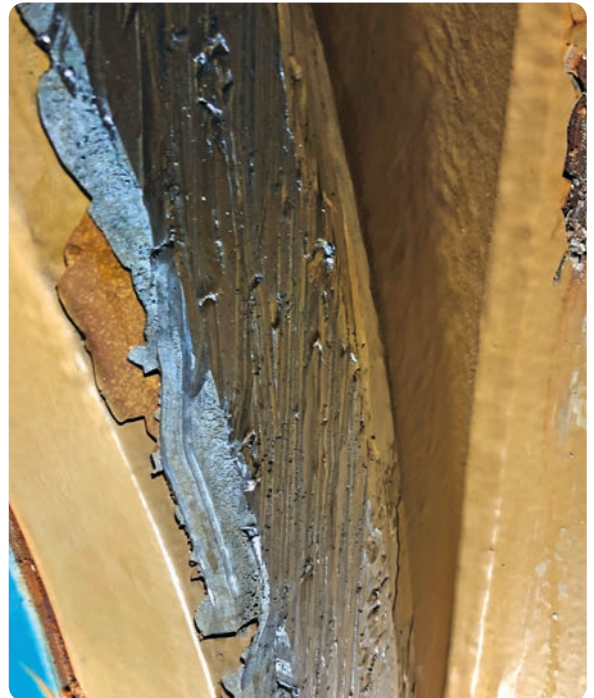
Galled material on valve face
