The effects of changing plant operational modes on Boiler Water Circulation Pumps

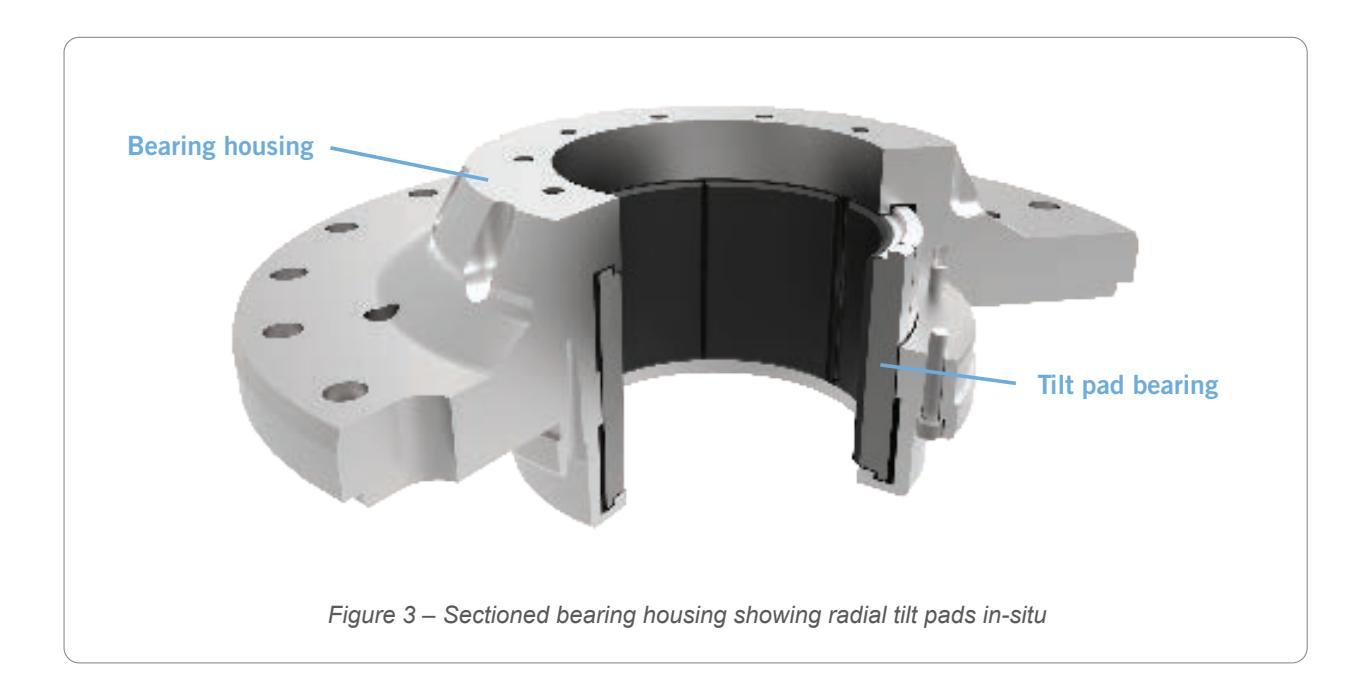
Similar to the thrust bearings, the radial bearings in the BWCP use hydrodynamic bearings. The radial bearings are located at the thrust end and pump end. Accurate alignment of the radial bearing is controlled by manufacturing tolerances of the stator housing and motor case. The radial bearings are sized to absorb loads from unbalanced magnetic pull (UMP) on the rotor, hydraulic fluctuations in the pump creating unbalanced loads and ensure safe rotor dynamic characteristics. When the BWCP starts there is insufficient fluid film between the journal sleeve and the bearing surface. Like the thrust bearing this creates wear on the pads resulting in lost material and larger clearances. This is a propagating effect as the bearing wear allows the rotor to deviate from the center axis of the stator which increases the UMP and hence increases bearing wear. Increased bearing wear allows the rotor to deviate away from alignment with the stator and hence the damage propagates due to worn radial bearings. If the bearing clearances become excessively large under extreme conditions the UMP during start-up could cause rotor to stator contact due to bending in the rotor. This could cause damage to the stator and rotor lamination packs resulting in the need for restacking.

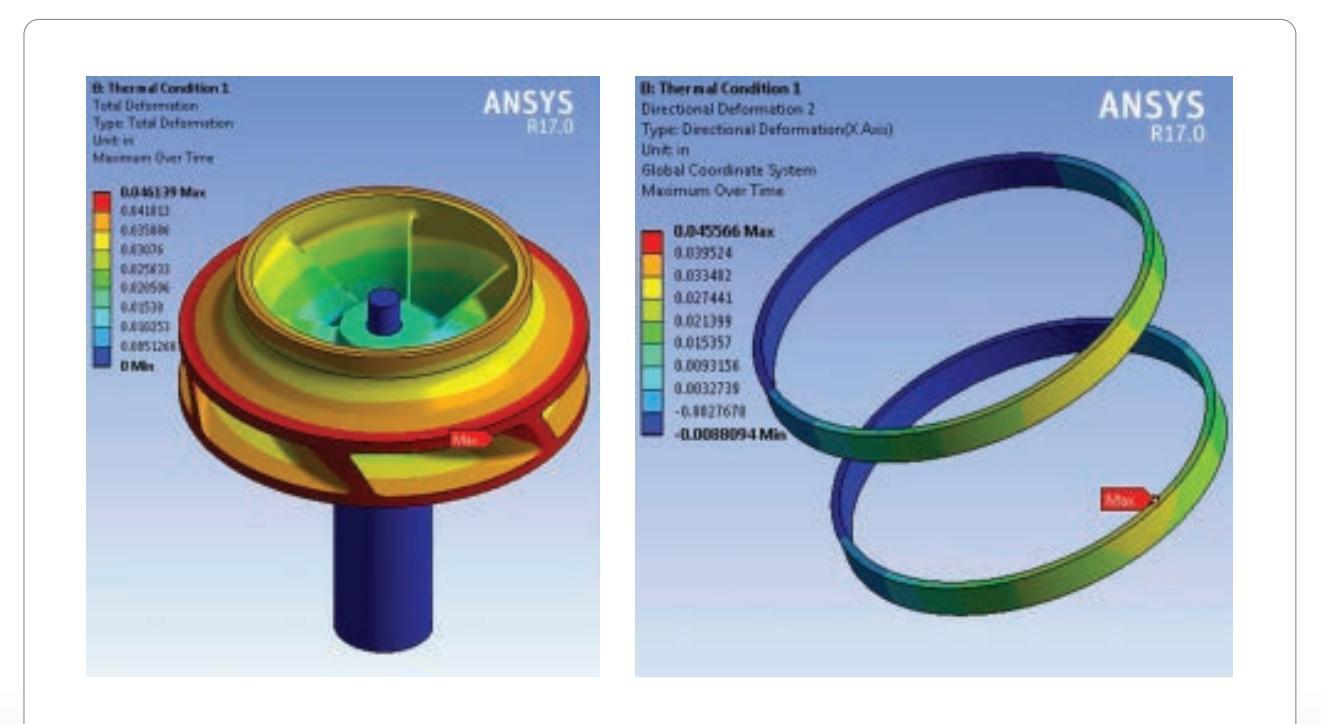
Figure 5 – Thermal expansion of impeller (left) and wear rings (right)

The impeller wear ring is set with a pre-determined diametrical clearance to the pump case/diffuser wear ring in order to control the pressure drop across the surface and the amount of fluid recirculated. In addition, the distance from the pump case to motor case mating face and end of the impeller (known as the "A" dimension) is controlled to ensure no axial contact. Under scenarios where the plant is quickly changing load or fully starting and stopping the motor there is typically a temperature difference between the pump case and rotating assembly. Depending on that temperature differential the impeller and pump case will grow or shrink at different rates from each other. This reduces the wear ring clearance and can cause contact. In severe situations binding of the rotating assembly to the static wear ring can occur. Frequent load changes will cause accelerated degradation to the wear rings. This increases the clearance and reduces efficiency (due to increased recirculation) but, more severely, shortens the life of the wear rings and can cause major damage to the impeller and rotating assembly. Excessive contact of the impeller to pump case can bend the rotor, damage the radial bearings and have consequential effects of damaging the stator windings due to debris being circulated through the motor.

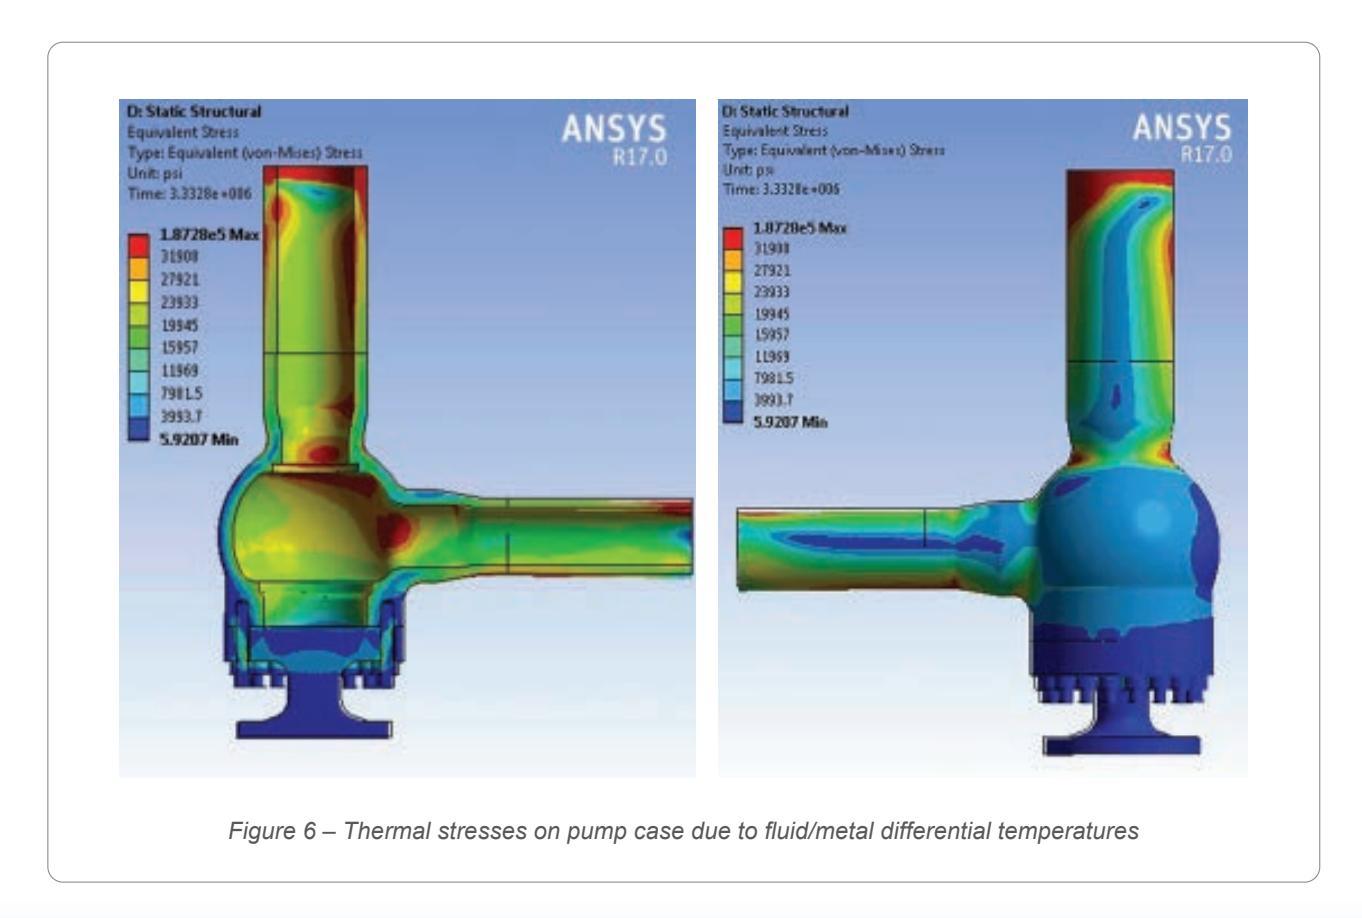
The above two images show the highest stressed areas of a representative pump case and are the areas that should be inspected first for fatigue cracking.

The pump case on a BWCP is welded into the pipework and typically made from a thick walled carbon steel casting. Frequent thermal cycling on the pump case due to changing operating loads subjects the pump case to thermal stresses as the pump case tries to expand freely however is constrained by the pipework and connection to the motor. Frequent thermal stress cycling can present problems with fatigue crack development at critical regions such as changes in thicknesses, nozzle regions and welds. Operators undertaking frequent load changes and thermal cycling should ensure to inspect pump cases for the development and propagation of cracking. If the pump case welds are not part of a maintenance program associated with "high energy pipework" they should be included in the periodic inspection of the pump case.

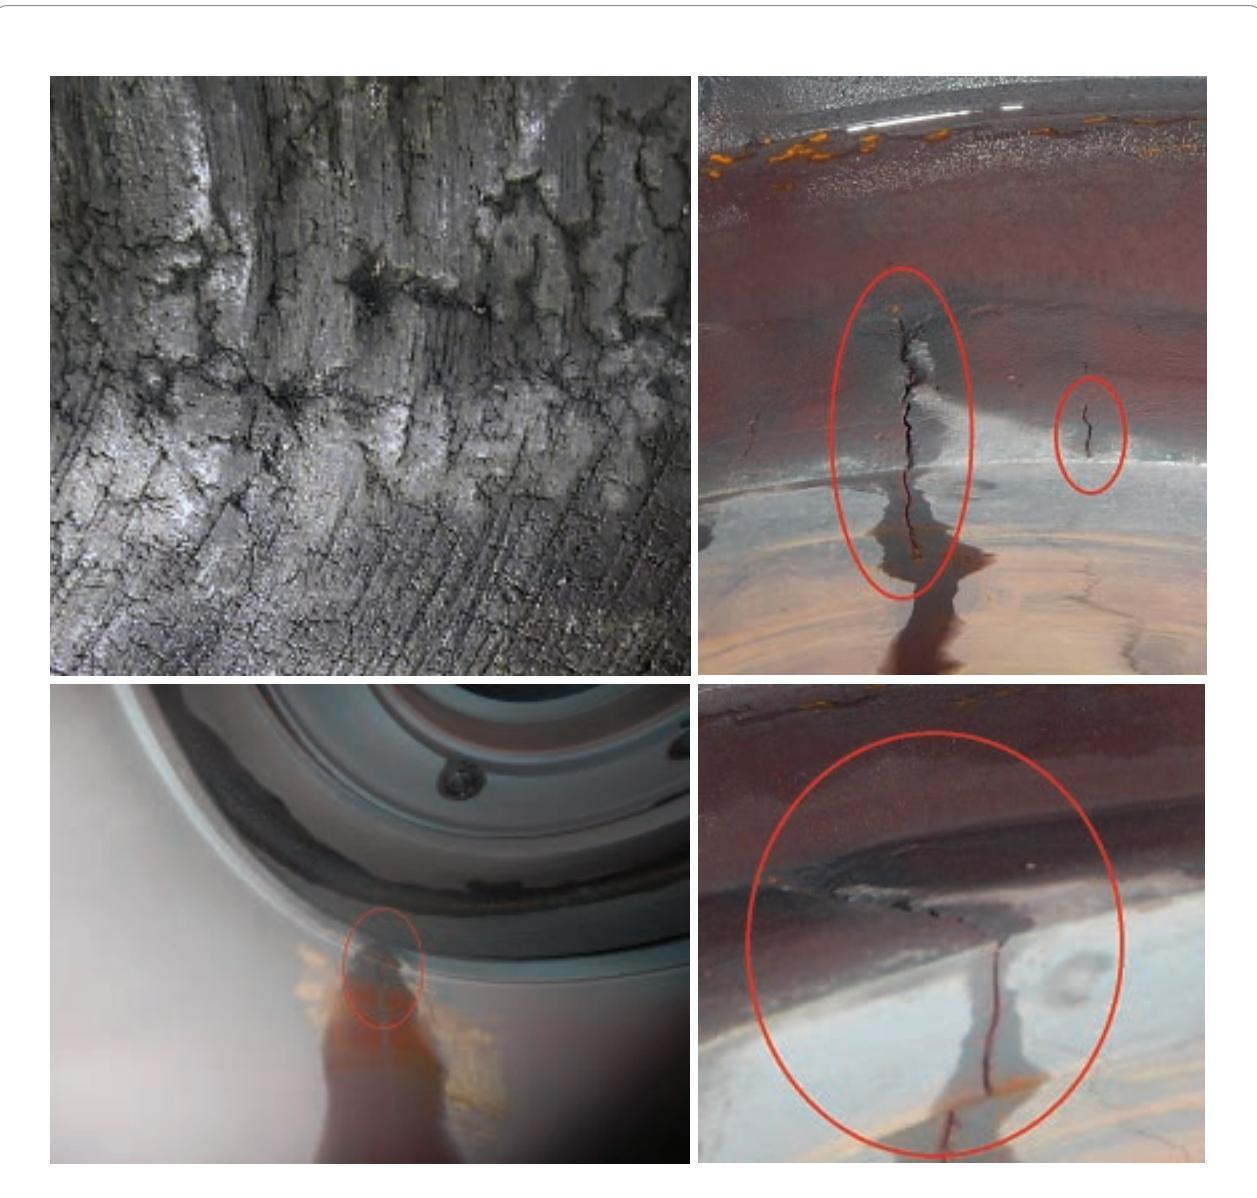
Figure 7 – Cracks in BWCP pump cases

The above images show cracking that was discovered in BWCP pump cases. The cracking caused extended downtime for the plants invloved.

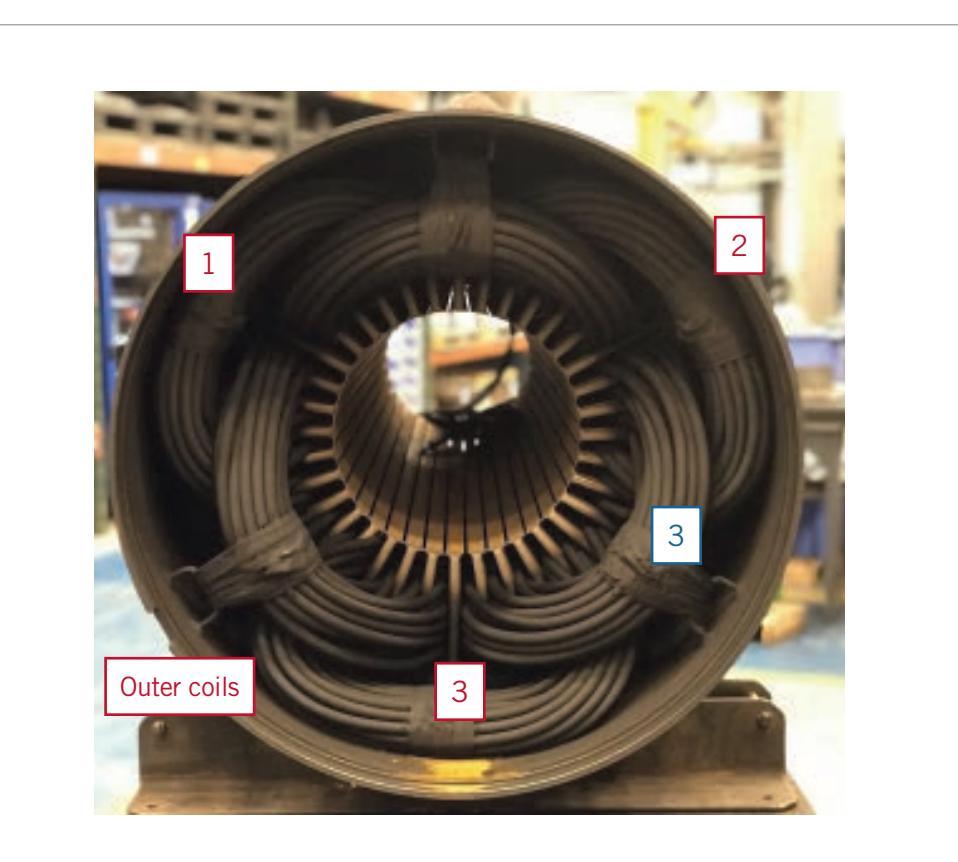
Figure 8 – Stator end turns showing coils

When the stator is initially wound the cable in the slots are wedged together to keep them packed tightly together. With normal operation of the electrical motor, the cable in the slots bunch together and pull to the outside of the stator due to the magnetic forces in the motor. This can have the effect of the cable becoming looser in the stator slots allowing additional cable movement. A typical 4 pole wind is shown below in figure 8.

During the start-up of the electrical motor the cable in the end turn phases exert magnetic forces on cables in adjacent end turn phases causing the end turns to move and vibrate. The outer coils are pushed towards the outside of the stator shell and the inner coils are pulled towards the rotor. The end turns flex with the changing magnetic fields induced by the incoming current.

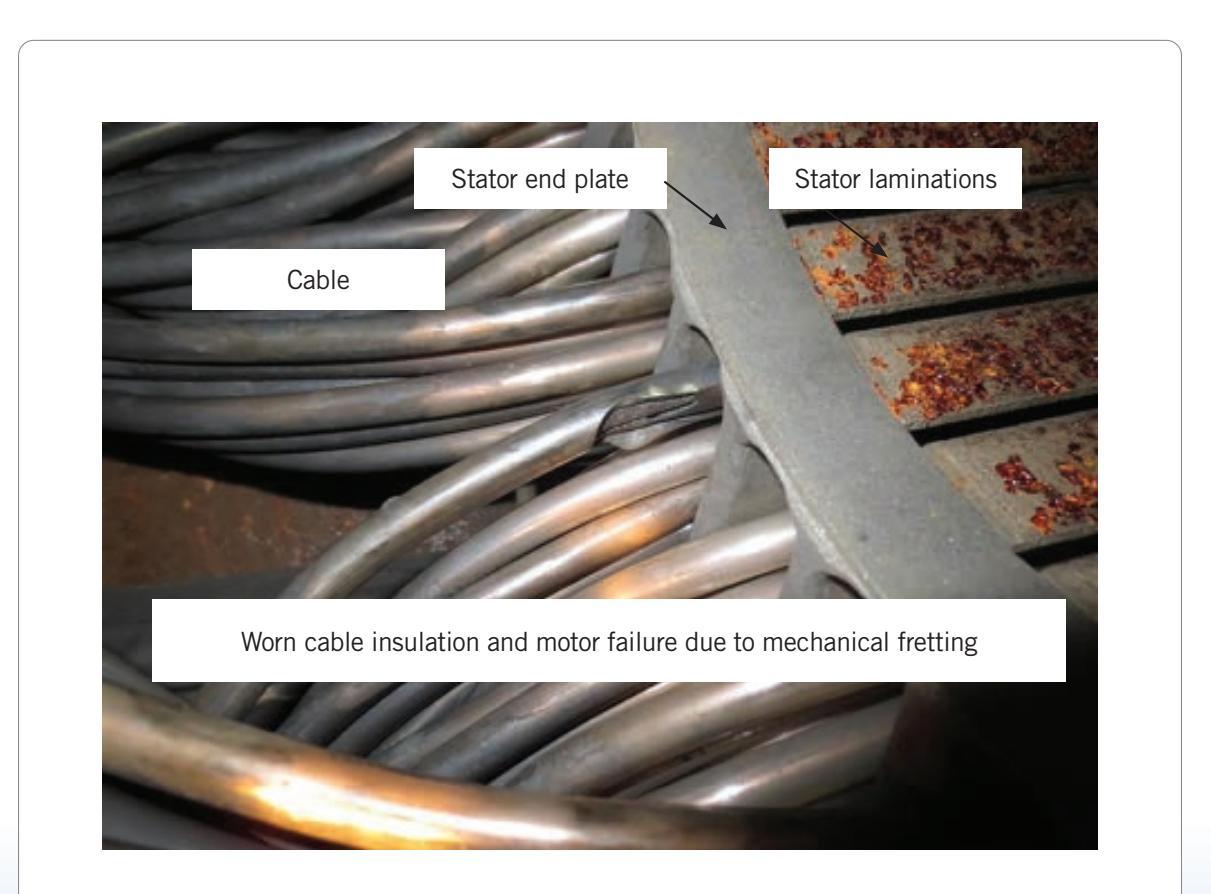
Figure 9 – Failure to ground due to mechanical fretting and insulation wear

Over time with high numbers of starts to the motor (more than originally designed), this end turn cable movement, combined with the increased movement in the slot can result in the cable rubbing on the stator end plate. If this behavior continues the cable insulation wears down until an insulation failure occurs (as shown in Figure 9). In some occasions the insulation failure causes an electrical arc which damages the stator end plate and stator laminations. This can mean a full or partial restack is necessary along with a stator rewind resulting in extended motor down time and significant repair costs.

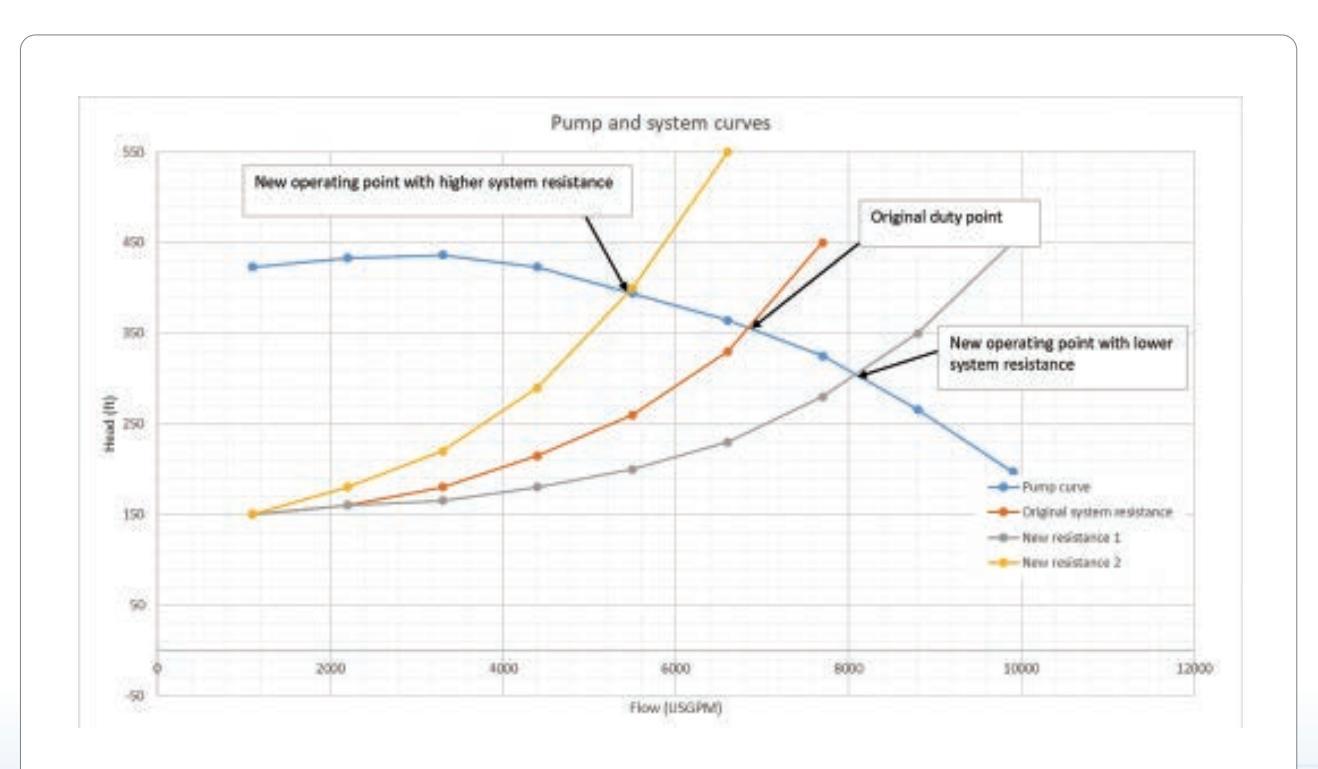
Figure 10 – Pump curve and various system resistance curves

Originally when the power plant was designed a system resistance applicable to the BWCP was calculated based on the designed static head plus the frictional loses due to pipework, valves, orifices etc. in the system. The frictional losses aspect of the calculation varies with the square of the flow. The pump will operate at the point where the pump curve and system curve intersect. The pump curve only changes if the speed of the motor is changed or the impeller diameter is changed, both of which are very uncommon on BWCP's. Changes to the system such as modified valve arrangements, changes to pipework configuration or diameter, degradation of drum baffles etc. all have an effect on the system resistance which in turn dictate where the pump operates along its pump curve. This can result in the pump being operated away from its originally designed duty point which can cause increased vibration in the BWCP. Increased vibration will result in accelerated damage to the radial bearings and thrust bearing. If the system resistance has increased the pump will run back on the pump curve i.e. lower flow, higher head. The increased differential pressure across the impeller can cause increased thrust on the rotating assembly accelerating bearing wear.

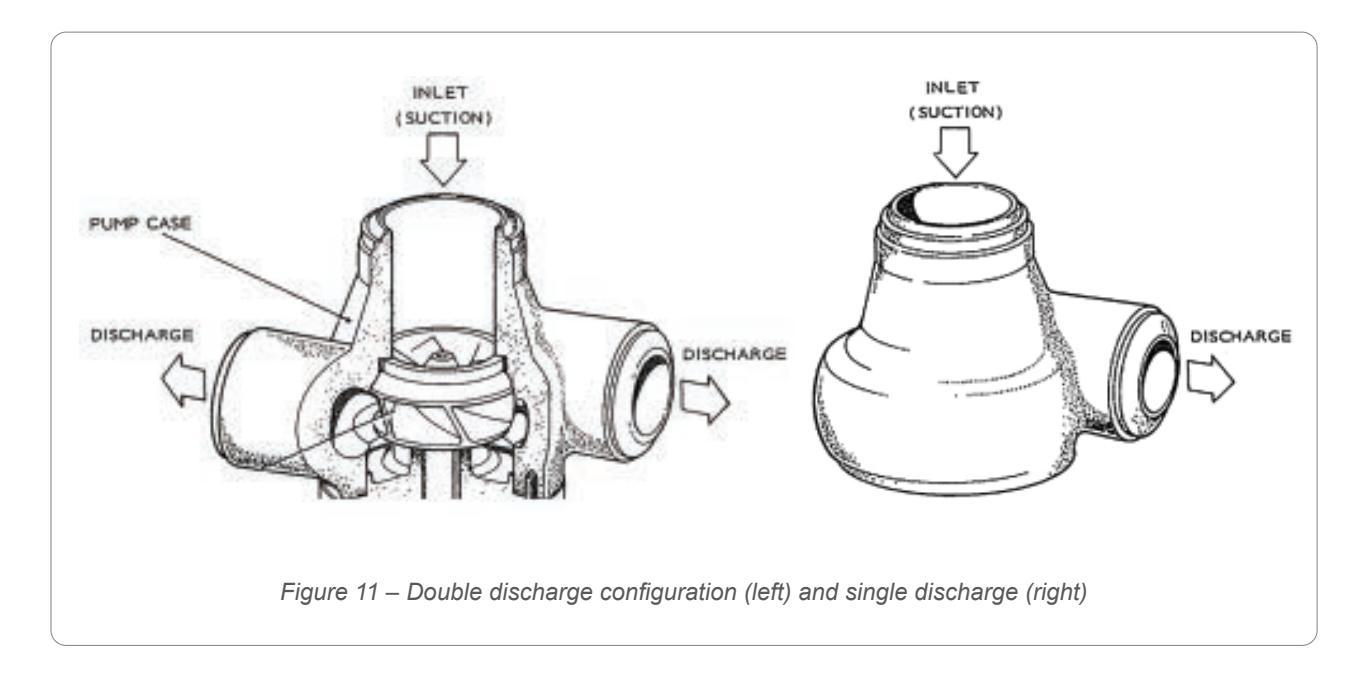
The BWCP either has a single discharge or a double discharge from the pump case as shown below.

In both cases the discharge pipework has an isolation valve to isolate the BWCP from the boiler. If the discharge valves are not well maintained they can partially close when un-intended and this has a negative effect on the BWCP. If the discharge valve is partially closed with the pump in operation it will force the pump to operate back on the pump curve with a large differential pressure across the pump. The increased differential pressure across the impeller can cause increased thrust on the rotating assembly accelerating bearing wear.

In the case of double discharge pump cases, if one of the discharge valves has not been maintained and floats to a partially closed position this effects the alignment of the impeller within the pump case. The impeller and rotating assembly will tend to locate away from the discharge with the partially closed valve. The off center alignment will cause un-even wear on the radial bearing which, as discussed previously, will increase the UMP on the rotor.

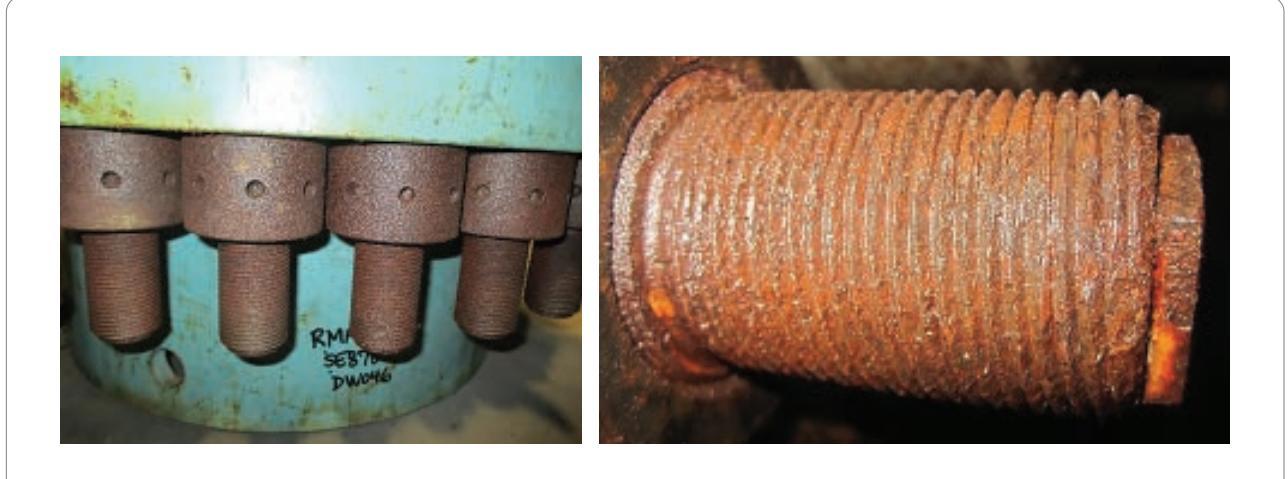
Figure 12 – Corroded motor cover studs (left) and close up of stud (right)

Long term neglect of the pump case and/or motor cover studs of a BWCP can cause them to corrode and seize in place. New pump case studs have a zinc phosphate coating to improve corrosion resistance and paint adhesion followed with a high temperature anti-friction coating. If the pump case/motor case gasket has leaked or the plant environment is frequently subject to water the studs can corrode and bind in place. Often the only way to remove the studs to allow servicing of the BWCP is to cut them out. This causes an unnecessary expense for the plant requiring them to purchase new studs, often on an expedited basis.
